AVIATION INVESTIGATION REPORT

A00P0244

CONTROLLED FLIGHT INTO TERRAIN – ON APPROACH

**PIPER AEROSTAR 602P N88AT
OKANAGAN MOUNTAIN, BRITISH COLUMBIA
31 DECEMBER 2000**

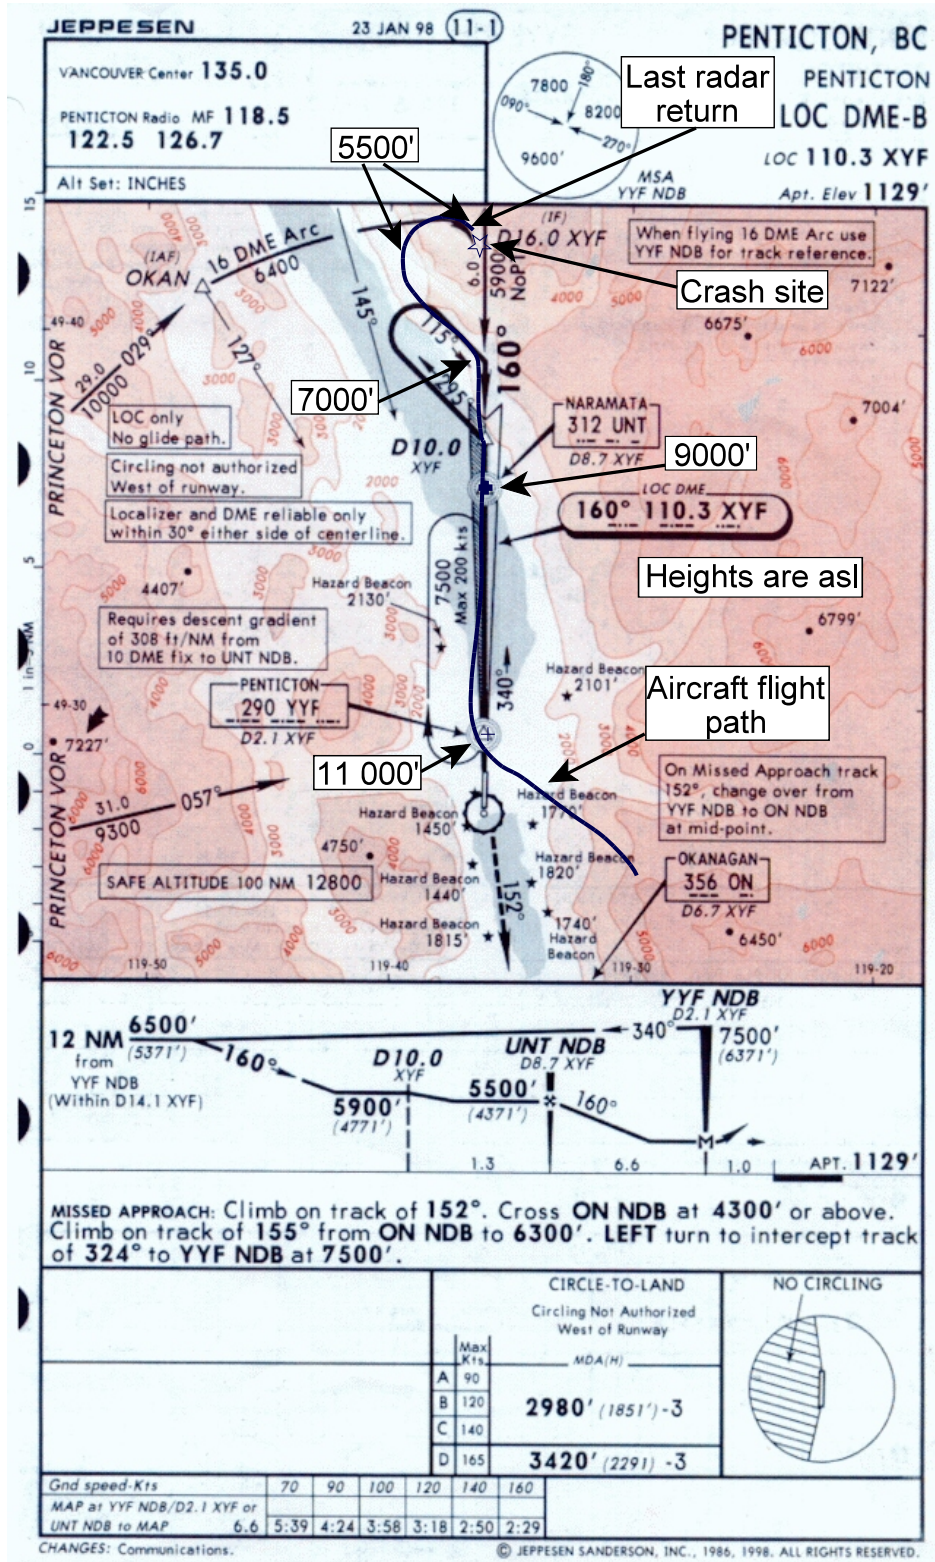
Appendix A - Penticton Approach Chart

As shown in Appendix A, the LOC DME-B approach at Penticton, a non-precision approach, commences at the Penticton non-directional beacon (YYF NDB) at a minimum altitude of

- track outbound on the localizer, past the UNT (Naramata) NDB until 10 DME;
- make a left procedure turn at a minimum altitude of 6500 feet, completing the turn within 14.1 DME [using DME from XYF 110.3];
- proceed inbound on the localizer at a minimum altitude of 5900 feet until 10 DME;
- descend to a minimum of 5500 feet at the UNT NDB; and
- descend to a minimum of 2980 feet to the YYF NDB, the missed approach point.

The pilot tracked outbound on the localizer for one minute from the UNT NDB, and his procedure turn commenced at 13 DME. This was 3 nautical miles (nm) past the 10 DME turning point depicted on the approach chart and already at the controller / pilot agreed limit. The delay in starting the procedure turn resulted in the aircraft reaching 16 DME before the turn was

completed, 1.9 nm past the chart limit. The aircraft was 1000 feet below the minimum altitude for the procedure turn, and as the aircraft turned to intercept the localizer, it was 400 feet lower than the minimum safe altitude for that area, which is 5900 feet asl.
